### Project information

Project type:	ECO – Refurbishment
Address:	Manuel Robles Pintado 5, Benito Caparroso Paños 3,11
Rehabilitation year:	2011
Building type:	Multi-level block of apartments
Dwellings:	44
Storeys:	5
Gross area BTA:	4506 m <sup>2</sup>
Net area:	3482 m <sup>2</sup>
Heated area:	3806 m <sup>2</sup>
Additional costs* for eco-a	
Applications:	184.992 €
Total building cost*:	682.371 €

### Special ECO-technologies applied:

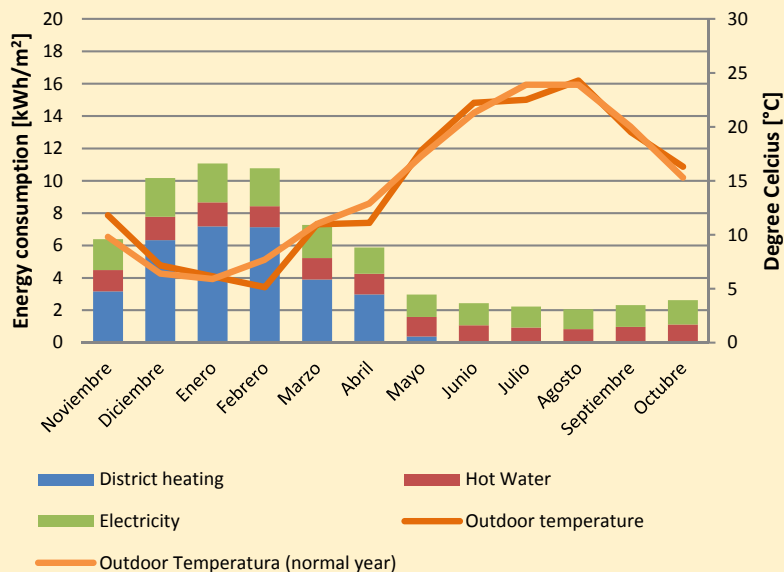
### Energy consumption 2011-2012

Energy consumption	Unit	60's National Regulation	Concerto spec.	Actual 2011-2012
Heat	kWh/m <sup>2</sup>	110	58	31.1
Hot water	kWh/m <sup>2</sup>	20	-	14.3
Electricity	kWh/m <sup>2</sup>	25	-	20.8
<b>Total</b>	<b>kWh/m<sup>2</sup></b>	<b>155</b>	<b>58</b>	<b>66.2</b>

Energy consumption	Unit	Normal practice	Concerto spec.	Actual 2011-2012
Heat	kWh/m <sup>2</sup>	110	58	31.1
Pipe losses	kWh/m <sup>2</sup>	Inc	Inc	Inc
Ventilation	kWh/m <sup>2</sup>	Inc	Inc	Inc
Hot water	kWh/m <sup>2</sup>	20	Inc	14.3
<b>Total heat</b>	<b>kWh/m<sup>2</sup></b>	<b>130</b>	<b>58</b>	<b>45.4</b>
Lighting	kWh/m <sup>2</sup>	Inc	-	Inc
Other	kWh/m <sup>2</sup>	25	-	20.8
<b>Total elec.</b>	<b>kWh/m<sup>2</sup></b>	<b>25</b>	<b>-</b>	<b>20.8</b>
<b>Total</b>	<b>kWh/m<sup>2</sup></b>	<b>155</b>	<b>58</b>	<b>66.2</b>
