### Project information

| Project type: | Eco-rehabilitation |
| Address: | Clemos Burgaleta 1,3 |

### Special ECO-technologies applied:

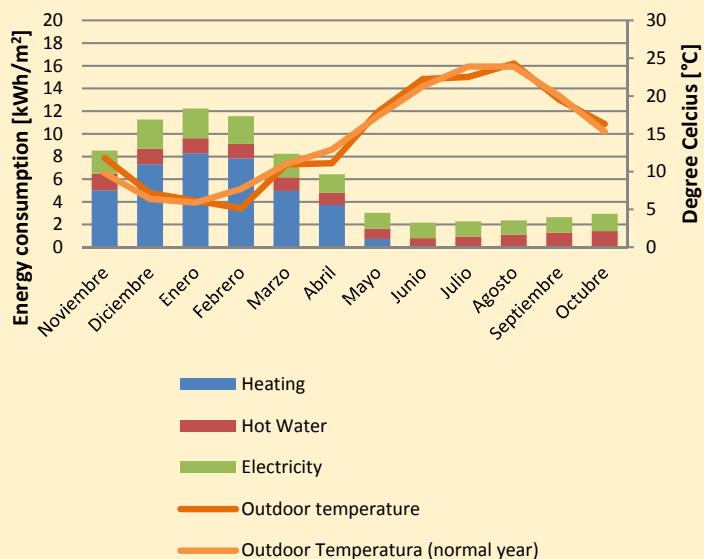
### Energy consumption 2011-2012

| Energy consumption | Unit | National reg.* | Concerto spec. | Actual 2011-2012 |
| Heat | kWh/m <sup>2</sup> | 125 | 58 | 37.9 |
| Hot water | kWh/m <sup>2</sup> | 20 | - | 14.2 |
| Electricity | kWh/m <sup>2</sup> | 25 | - | 21.6 |
| Total | kWh/m <sup>2</sup> | 170 | 58 | 73.7 |
