Project information

Project type:	Eco-Refurbishment
Address:	Rafael Delgado Garcés 4,6,8,10,12
End rehabilitation year:	2011
Building type:	Blocks of dwellings
Dwellings:	90
Storeys:	5
Gross area BTA:	9431 m ²
Net area:	7730 m ²
Heated area:	7034 m ²
Additional costs* for eco-applications:	483.674 €
Total building costs*:	1.366.065 €

Special ECO-technologies applied:

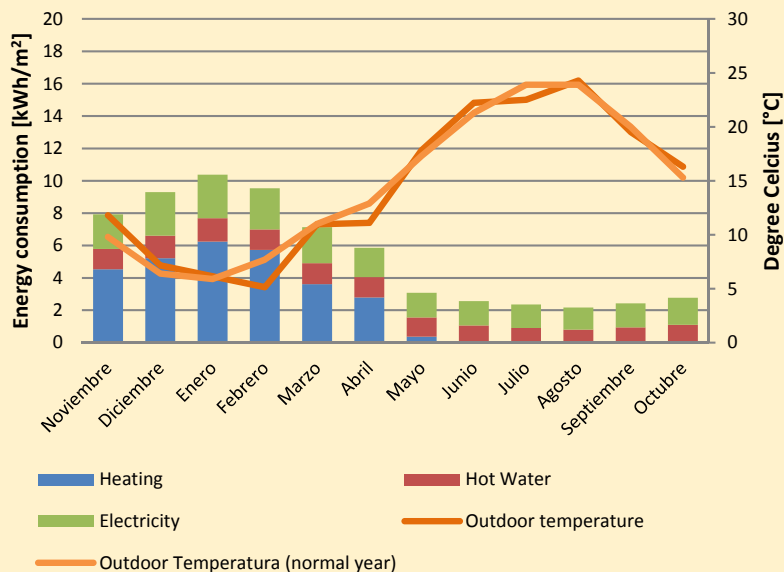
Energy consumption 2011-2012

Energy consumption

Energy consumption	Unit	60's National reg.	Concerto spec.	Actual 2011-2012
Heat	kWh/m ²	110	58	28.5
Hot water	kWh/m ²	20	-	14
Electricity,	kWh/m ²	25	-	23.1
Total	kWh/m²	155	58	65.6
PV field	MWh	-	-	19.5
