Photovoltaic roofs, Tudela

BEST 1: Residential new buildings

IAS Gestión, Tudela

BEST 2: Refurbishment

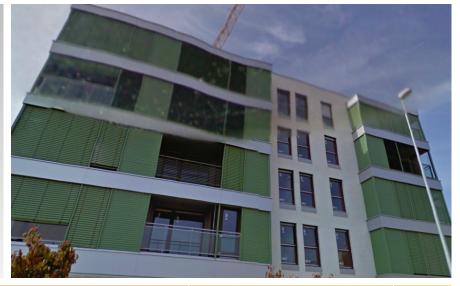
Energy consumption

Heat trans.

National reg.* Concerto spec.

Outerwall	W/m²K	0.66	0.3	0.29
Roof	W/m²K	0.49	0.2	0.19
Floor	W/m²K	0.49	0.25	0.25
Windows North	W/m²K	3	_	_
Windows South	W/m²K	3.5	_	-
Glazing	W/m²K	—	1.6	1.6
Vent. rate	h ⁻¹	1	0.5	0.5
Energy consumption	h ⁻¹ Unit	1 National reg.*		0.5 Actual 2012
				Actual
Energy consumption	Unit	National reg.*	Concerto spec.	Actual
Energy consumption Heat	Unit kWh/m²	National reg.*	Concerto spec.	Actual
Energy consumption Heat Hot water	Unit kWh/m² kWh/m²	National reg.* 53.6 18	29.7 14.5	Actual

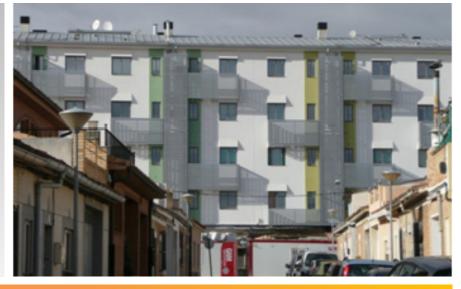
Energy consumption 2011-2012 30 20 Energy consumption [kWh/m²] 18 25 16 14 12 10 10 Hot Water Heating Outdoor temperature Electricity Outdoor Temperatura (normal year)

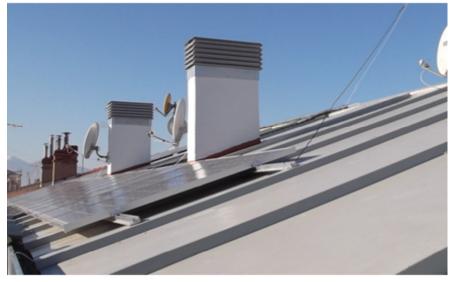
Energy consumption

Heat trans.

Outerwall	W/m²K	0.66	0.66	0.442
Roof	W/m²K	0.49	0.38	0.265
Floor	W/m²K	0.49	0.5	0.25
Windows (north)	W/m²K	3	_	-
Windows (south)	W/m²K	3.5	_	_
Glazing	W/m²K	-	1.7	1.67
Vent. rate	h ⁻¹	1	0.5	0.5
Energy consumption	Unit	National reg.*	Concerto spec.	Actual 2011- 2012
· .	Unit kWh/m²			Actual 2011-
consumption		reg.*	spec.	Actual 2011- 2012
consumption Heat	kWh/m²	reg.*	spec.	Actual 2011- 2012 37.9
consumption Heat Hot water	kWh/m²	reg.* 125 20	spec. 58	Actual 2011- 2012 37.9 14.2
